# International Journal of Advanced Research in Education and Technology (IJARETY)

Volume 9, Issue 3, May-June 2022

# Evaluation and Comparison of the Effects of Moisture Content on Building Materials in Water Edge Construction: A Case Study of Munroe

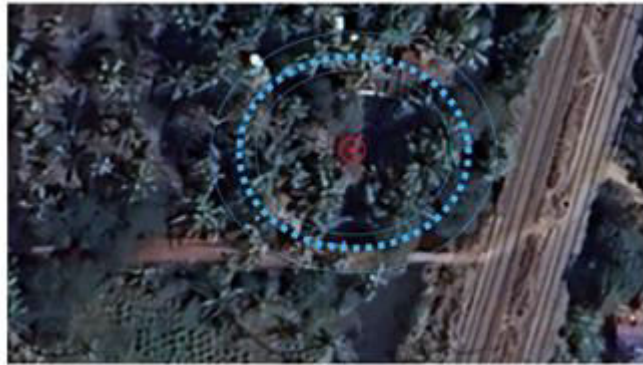
Figure 1: location showing Residence 1

**Case 1: Fully painted concrete structure**

A Small residence built of long time surroundedby small water bodies that affects the building conditions and its strength.

Built using concrete flooring, concrete walls withplastering, and sheets for roof.

- Permanent failures of paints and coatings.
- Corroding of walls and floor.

CASE 1	EXTERIOR			INTERIOR		
	MAX	MIN	VALUE	MAX	MIN	VALUE
TEMPERATURE	33.3°C	26.8°C	33°C	33°C	26.8°C	31.7°C
HUMIDITY	89%	68%	75%	89%	68%	80%

Table 1: Temperature and Humidity of Residence 1

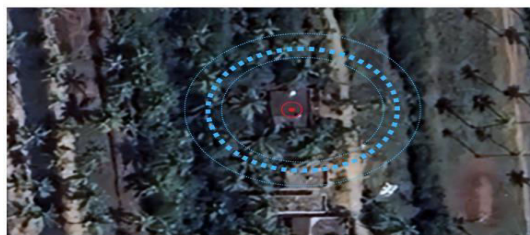
Figure 2: location showing Residence 2

**Case 2: Exposed brick structure**

A Small residence built of long time surroundedby small water bodies affects the building conditions and its strength.

Built using exposed brick painted outside, terracotta roof.

- Permanent failures of paints and coatings
- Corroding of walls and floor
- Moisture presence found in walls

CASE 1	EXTERIOR			INTERIOR		
	MAX	MIN	VALUE	MAX	MIN	VALUE
TEMPERATURE	32.9°C	26.8°C	32.7°C	33°C	26.8°C	31.9°C
HUMIDITY	89%	68%	81%	89%	68%	80%

Table 2: Temperature and Humidity of Residence 2

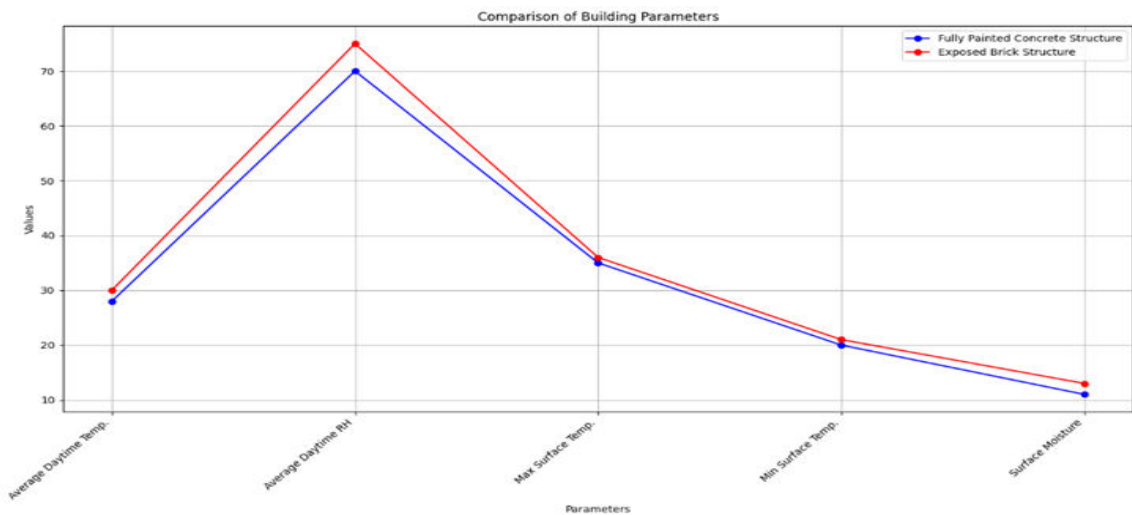
Figure 4: Line graph showing parameters-based analysis of 2 Residences

When exposed to water-edge environments like Munroe Island, an exposed brick surface tends to retain more moisture compared to a fully painted concrete structure,

1. **Porosity:** Exposed brick is inherently more porous than concrete, which means water can seep into its surface more easily and increase moisture content.
2. **Absorption:** Brick absorbs water at a higher rate than concrete, making it more prone to taking in moisture from the environment.
3. **Capillary Action:** Brick is also more susceptible to capillary action, where water moves upward through the brick's pores, further raising moisture levels.
4. **Lack of Protection:** Without a protective layer like paint, exposed brick is especially vulnerable to water ingress and moisture retention.

In contrast, a fully painted concrete structure offers better protection against moisture. The paint helps by:

1. **Sealing Pores:** It fills in the pores of the concrete, which reduces its ability to absorb water.
2. **Protecting from Water Ingress:** The paint acts as a hydrophobic layer that prevents water from penetrating the concrete.
3. **Reducing Capillary Action:** Paint also minimizes capillary action, which lessens the amount of water that can rise through the concrete.
